ART calls on all BlackBird owners to replace the **upper bearing pin of the friction enhancer** along with the corresponding screw.

“Nose” – Right Side Plate of the Friction Enhancer

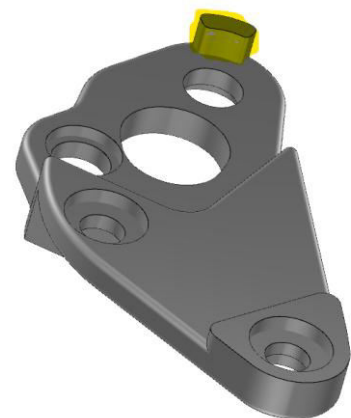
A few climbers have also informed us that the “nose” on the friction enhancer has broken off. The nose stop is designed to regulate the clamping movement of the friction enhancer.

If the nose breaks, the friction enhancer can extend fully, causing the entire system to lock up. There is no risk of a fall in this situation.

We have already reinforced this area with two stainless-steel pins, but this measure alone is not sufficient to completely prevent the shearing of the nose.

To address this issue as well, we have decided to manufacture the right side plate of the friction enhancer, and thus the “nose,” from stainless steel. This significantly increases the material strength and greatly enhances the overall robustness of the BlackBird. At the same time, we have optimized the contours to limit the weight increase to only 40 grams.

You may choose whether to have the side plate replaced as a precautionary measure or only in the event of a damaged “nose.” The replacement is **free of charge** and must be carried out at ART’s facility. We expect to be able to perform the full replacements starting in calendar week 49 and will begin accepting your returns from week 48.
